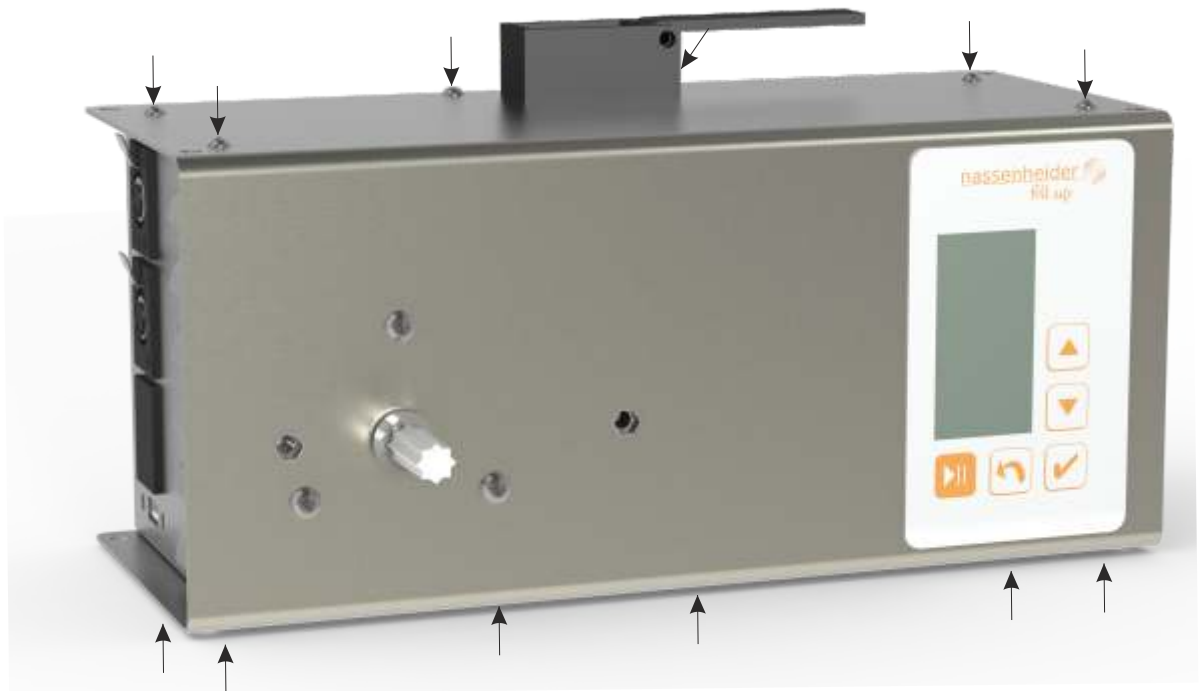
- 1) Remove all attaching parts from the Fill up 2 driving module, e.g. power cable, stand and gear pump module
- 2) Unscrew and remove all 6 screws at the top of the housing and the 6 screws at the housing base (see arrows) with a suitable Allen key.

- 3) The front and back part of the housing must be pulled apart only a few centimetres until the defective clamping lever can be removed
- 4) Insert the new clamping lever at the same position
- 5) Push together both parts of the housing and screw in again the 12 screws.
